# Bosma Startracker Series EM11 EQ Mount

## Part One

By: Mark Nordle

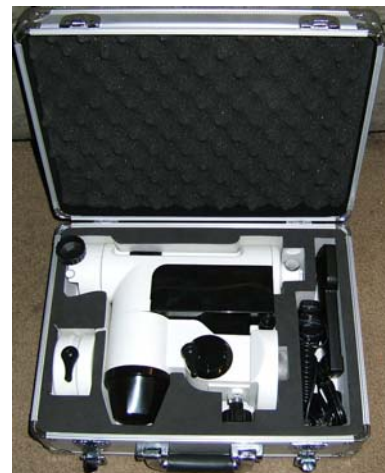
The head, hand controller, counterweight, power cord, and tripod come shipped in 2 boxes. Opening up the mount head box we find that the head assembly, counterweight, controller, and power cord comes shipped in its own case. Case dimensions are 16 1/2 long x 12 1/4 high and 6 1/4 wide.

The inner lid uses black egg carton foam found in most cases; the bottom uses what looks like 2 individual pieces of white molded medium density foam. The bottom is one piece, and the molded section is glued to the bottom piece, forming the padded cavities. The total packed case weight is 25 Lbs.

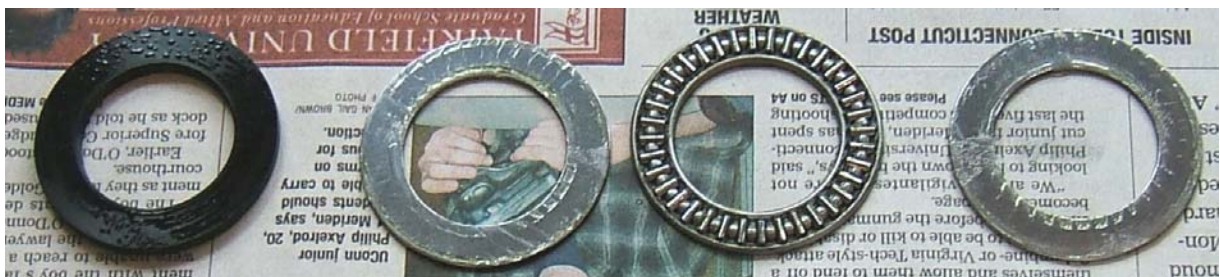
Dec axis saddle showing saddle retaining ring

Getting to the Dec locking ring was fairly straightforward. Remove the retaining ring, roller thrust bearing, loosen the lock, then lift the saddle. This exposed the saddle mount collar, with the shaft locking ring below it. The saddle plate lock actually locks on the saddle mount collar and not on the shaft directly.

Two heads was found to have a loose saddle plate. Tightening the retaining ring screwed to the black cap that’s held on with 2 bolts at the top of the axis solved that.

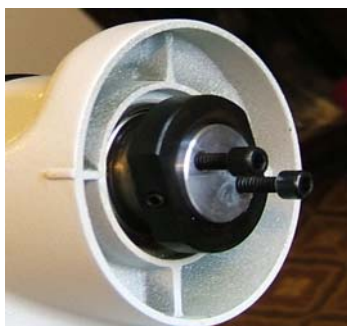
Dec shaft locking ring loosened with the saddle mount collar removed

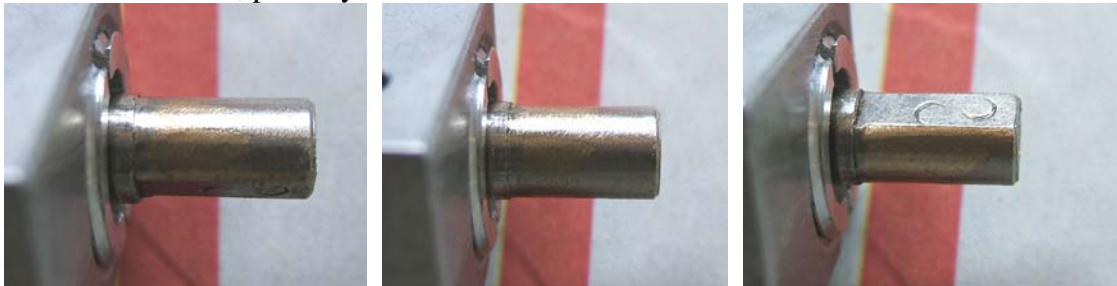
There also seems to be some run out in the shaft, indicating either worm thread to shaft run out, or a slightly bent shaft. After removing the worm shaft housing and spinning the shaft by hand, I found that the shaft drive gear also has excessive run out on 2 axis. Looking at the gear to worm shaft fit finds that the end of the shaft where the gear fits was filed by hand to fit the gear, as well as having the inside of the hole in the gear filed somewhat. I'm not sure what the issue is here, or what the person assembling this was attempting to fix. Either the shaft end is oversize, or the hole in the gear for the shaft is undersize, possibly both in this instance.

File marks galore, unequal filing, and an indication that the gears were put on and removed once before I received the mount

Getting the gear off the shaft was difficult. Replacing it was just as hard. The filing on the shaft and gear is probably the cause of gear issues here. The gear runs both out of round radially and wobbles side to side.

The worm housing uses bearings between housing and shaft with a threaded locking ring similar to Orions SVP setup minus the ring locking nut. The locking ring seems to be locktightened into place, and I was not able to adjust it. The above picture shows the end of the locking ring, as well as the file marks I found all around the end of the shaft.

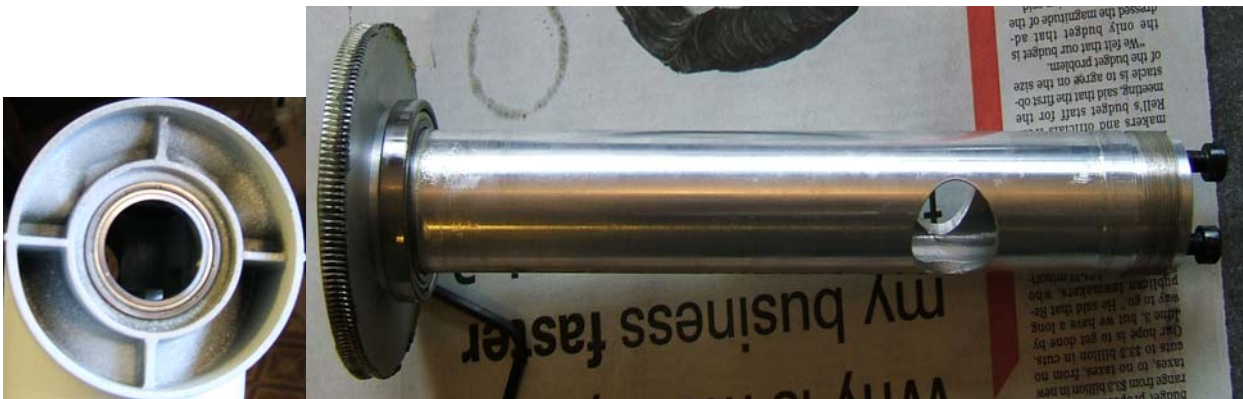
The Dec. shaft uses 2 6806Z bearings. One in the top of the dec housing under the dec shaft locking cap, and one slipped onto the underside of the dec driveshaft gear.

Top bearing in the Dec housing, and the bottom bearing on the Dec drive shaft

Both bearings were smooth, and free, with no play between inner and outer races. The bearing in the top of the dec housing came out with a gentle lift, and went in smoothly. The fit between housing and bearing is very close, and doesn't seem to wobble at all when inserted into the housing. There was no machining in the bearing area of the housing that I could tell. It seems the castings are very accurate. The Dec. driveshaft goes in the housing from the bottom. This places the gear at the bottom of the housing, instead of the top like most GEM mounts. The shaft locking ring is at the top and has 2 setscrews to hold its position after tightening. The lower bearing to housing fit was slightly looser at the bottom, but had no noticeable play when inserted. The fit on the shaft was free, with no play.

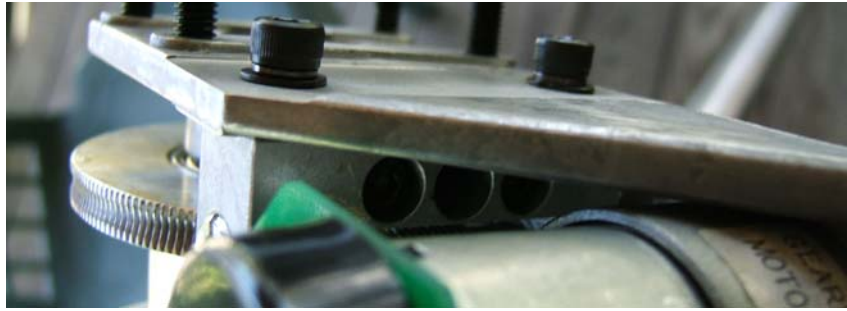
After removing the motor drive gear, I found that the worm to gear spacing was tight, and has a tighter spot just like the Dec. axis. They both use the same shaft from the looks of it, so the same problems follow from one axis to the other. The only difference on this axis is that instead of filing the gear end of the shaft, it was polished slightly. With the worm housing removed, there is no appreciable run out in the gear. There is a tiny bit of wobble, but nothing like the Dec. axis had.

RA worm gear adjustment location. Yes, it's buried.

Adjusting the RA worm to gear mesh involves removing the gear from the motor, then removing the motor from the casting. Taking the gear off exposes the 3 screws that are used to set the worms position. Once the worm mesh is proper, replace the motor, leaving the screw behind the gear somewhat loose then slide the gear on, and see how much play there is between the gears. Loosen the other 2 motor mount screws to be able to use the play in them to set the mesh and check the feel with the gear on, but free. If good, tighten the last screw on the motor behind the gear, replace the gear, and tighten the rest of the screws and you're done.
